Notes regarding KRX clutch assemblies/ noted problems

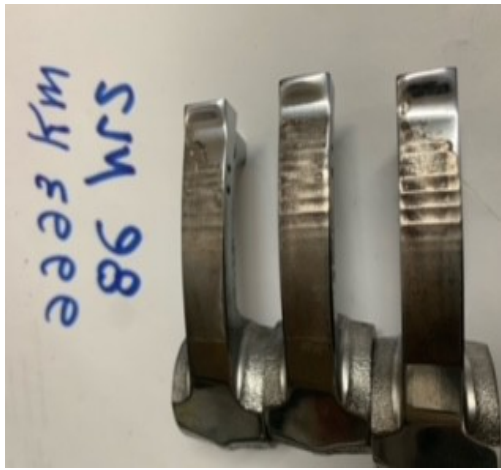
1) Flyweight roller surface wear (wavy/notched roller surface) The picture to the **right** is a stock flyweight with about 1000 miles. This one is minimal compared to some we have seen, but by 1000 miles, it seems, many can expect something like this. The picture **left** is a part of a set from a unit that has approximately 2200 Km

(1300 miles) on it. We expect that the worn surface could be caused by two separate reasons. We are of the opinion that the structure of the stock flyweight helps start the problems.

1) The factory flyweight is a somewhat soft cast material, that has some type of hard surface like Chromium on the top surface. We have found that hard coating to crumble off in short order on some of these. When that hard surface flakes and deteriorates, it

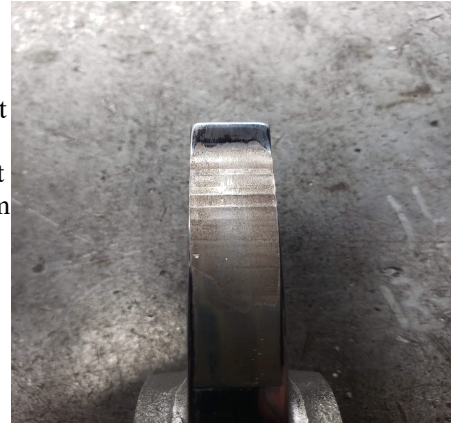
impregnates the surface of the primary roller with hard dust that makes the roller surface somewhat abrasive. The picture to the right shows the abrasive surface of the roller, and the chrome deteriorating on the flyweight from only less than 100 miles on our test unit.

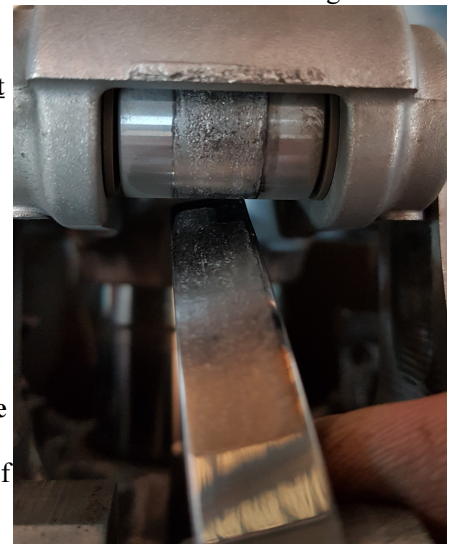
2) Bushing inside the roller. Even **more important** and we feel could be one main root of the clutch problems...**the bushings inside the primary rollers seem to be failing prematurely**. This bushing we suspect is not sufficient for this roller application, as it starts to be hard to roll under pressure very soon. **When these bushing start to fail, they stop the roller from having fluid rolling motion**. When the roller does not have free, fluid roller action, it drags on the surface of the flyweight.

We feel that between the abrasive surface, and the rollers not moving freely, ...it could cause premature wear on the flyweights.....**any flyweights**.

When the mechanic first inspects the rollers, at first they sometimes feel fine, but you must remember, that the primary rollers are under extreme pressure when the flyweights are at high RPM. The roller must be perfectly fluid and rolling. So **when you inspect, press HARD on it. It must be perfectly smooth and fluid motion**. If it feels slightly stiff, gritty, or like metal on metal when you press hard the bushing inside is no longer usable. There is also a good chance that the pin it rolls on is also scarred and no longer the perfect polished finish. If the roller can not roll perfectly smooth, they will wear the flyweight surface and make scars and notches. ...**which could contribute to the other common problem reported by dealers...the grooves in the sheaves**.

3) Grooving in the sheaves of a CVT clutch can happen from various reasons, water, ...constant riding at low speeds in high range, super hard belts, etc. However, in this case we feel that the resulting wear in other parts of the clutch can also disrupt smooth shifting motion of the sheaves and belt, which could accelerate this grooving.
